## ***Home Inspection Report***

# ***Mundy's Home Inspection Inc.***

<b>Client:</b>	Mr. Sample	<b>Inspection #</b>	12345
<b>Subject Property:</b>	345 Pick a Place Rd Lexington, KY 40511	<b>Date:</b>	8-18-2021
<b>Telephone No:</b>	859-123-4567	<b>Time:</b>	9am
<b>Building Type:</b>	Residential	<b>Age:</b>	1970
<b>Occupancy Status:</b>	Vacant with furnishings	<b>Sq. Ft.:</b>	5120
<b>Persons Present:</b>	Buyer, Buyer Agent	<b>Fee:</b>	\$720
<b>Inspection Service:</b>	Whole house	<b>Temp:</b>	Mid 70s
<b>Weather Conditions:</b>	Partly cloudy, warm	<b>Page</b>	27

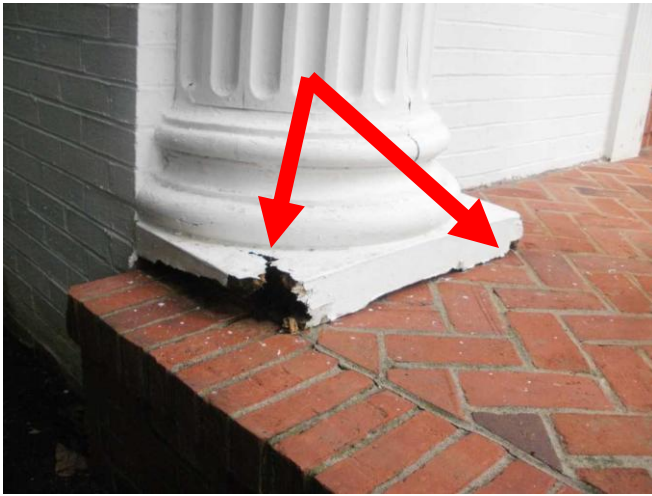
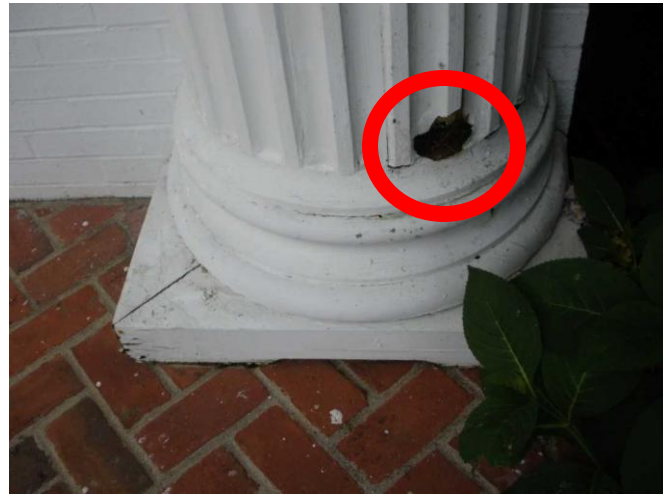
- \*1. Some areas of the front porch pillars (against the house) and trim are damaged. (The full ones across the front appear to be replaced with metal.) Areas of the soffit are damaged and some fascia (visible above the gutters and other areas) Correct and maintain as needed. (Ie- soffit at garage where it comes to the dining room, rear master where it comes to the family room and rear above meter base)

Damaged wood at pillars and trim against house.....Samples.

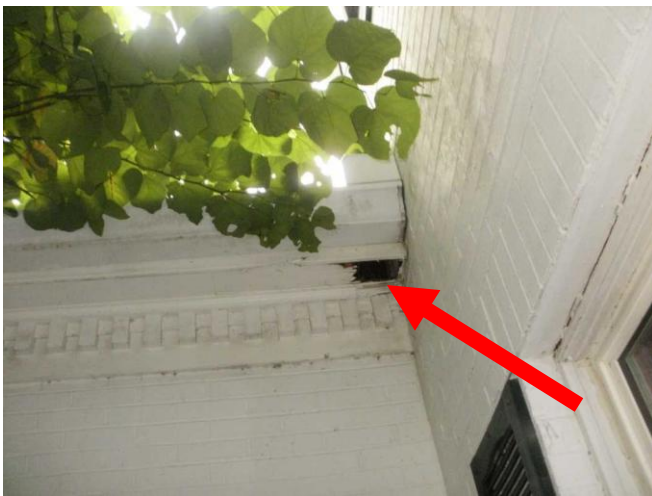
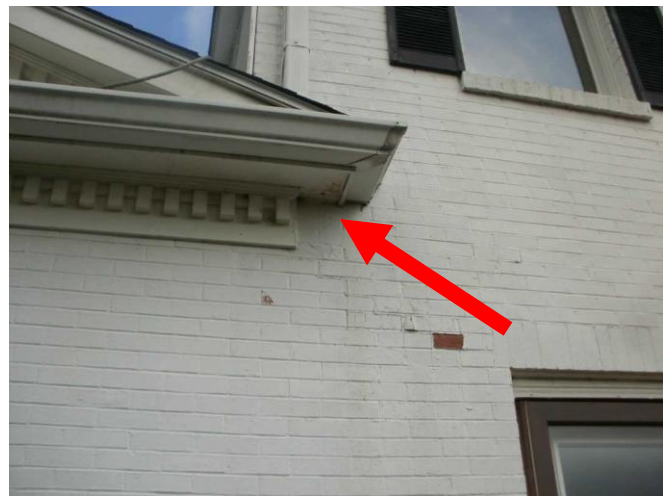
Sample damaged soffit by garage.....and at rear.

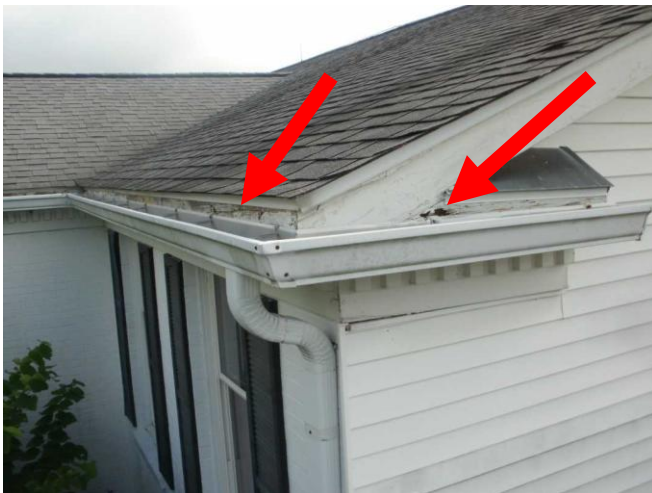
Sample at fascia above gutter and some trim.

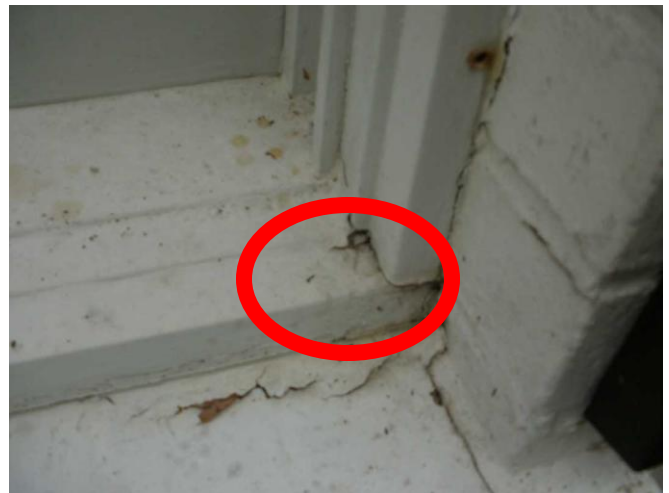
- \*2. Various older wood windows have damaged exterior window sills, frames and sashes. A variety of the doors have fogged glass and the storm doors don't function well. It appears the window seal has failed at the front hall(right side of front porch) left window. The basement front windows will need replaced. (Budget for older windows to be replaced) Correct as needed and maintain.

Sample window sill and trim damages.

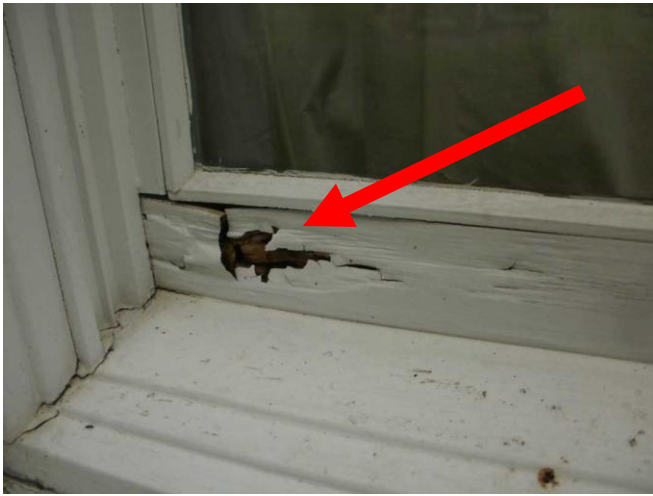
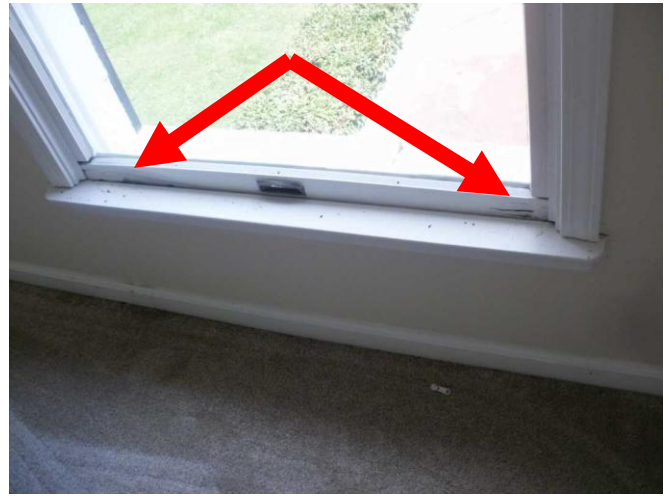
Sample sash damage at old wood windows.....Areas visible inside.

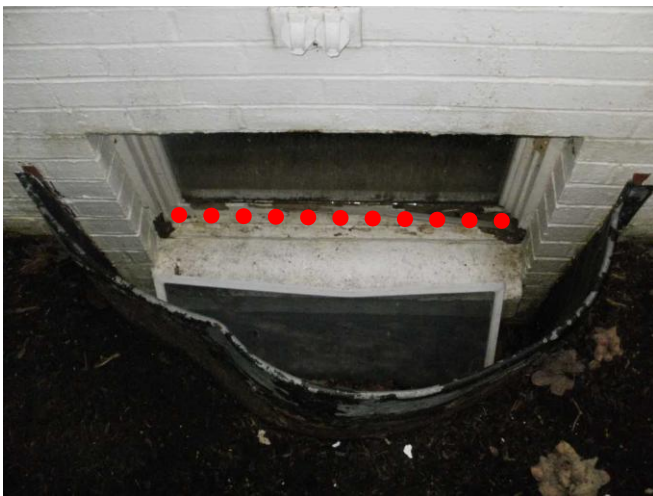
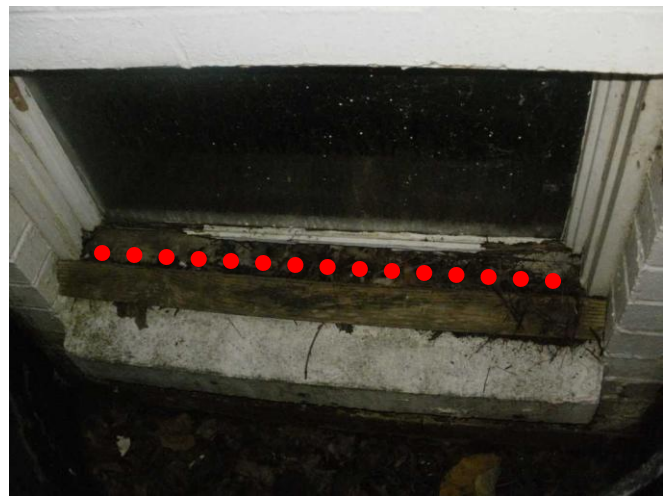
....and basement.....

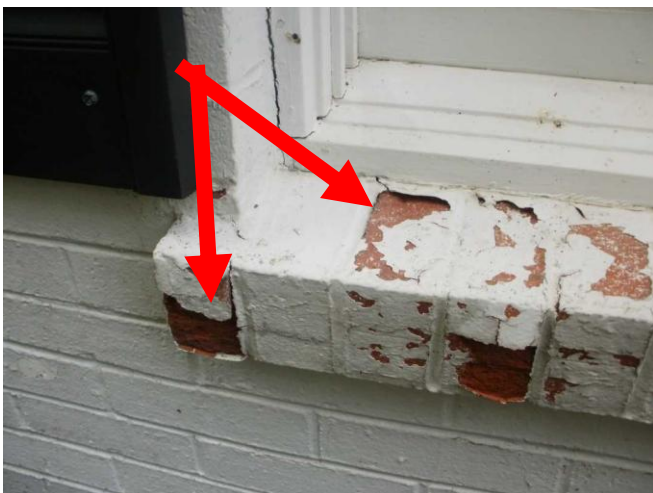
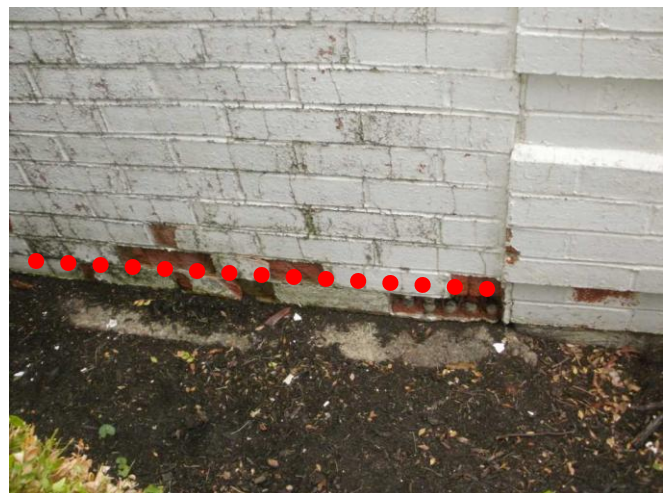
- \*3. Some brick (Mostly around the front, front porch area and rear patio area and patio walls) have brick spalling from water damage. The brick have been painted and paint is peeling in various areas of brick and wood.

Sample paint issues and brick damage.....various areas.

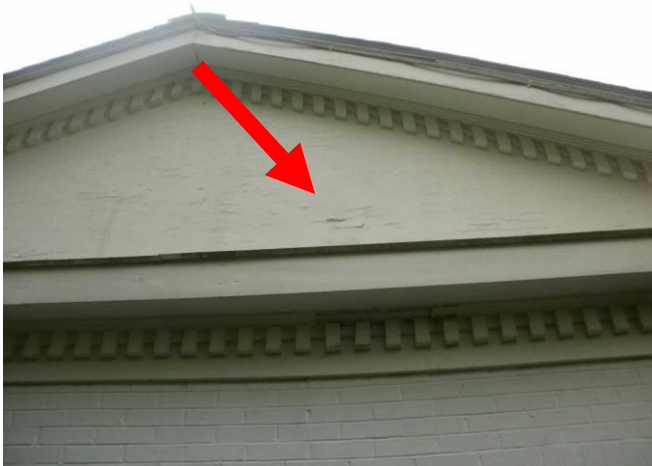
Sample paint peeling at wood areas also.

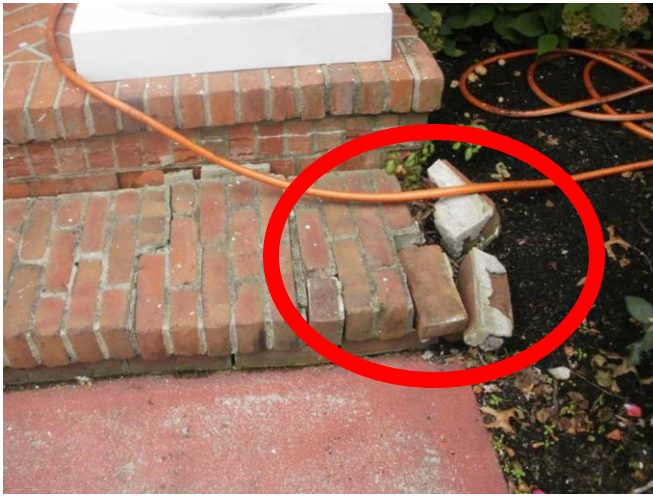
Sample steps damaged.

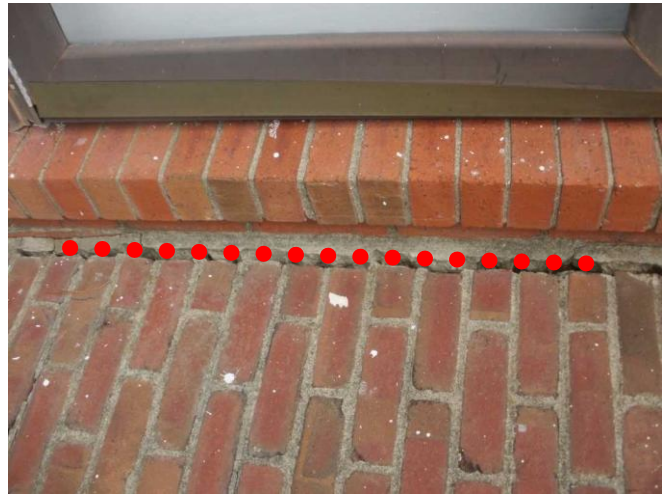
And settling at areas.

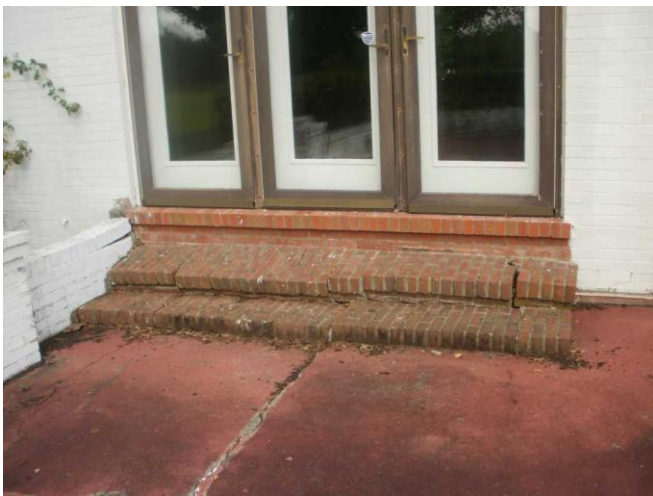
- \*5. The brick steps around the house are have differing step heights. Various areas (ie:rear steps off family room have settled and broken front porch steps have some loose or missing.) Various sidewalks have cracked, the side patio at office and rear patio has settled and slopes toward the house (Funneling water toward the rear of house.) Can be a trip hazard and should be replace and solid surface areas like patios and sidewalks against the house should slope away from the foundation. Some of the brick patio walls have broken in areas. Correct and maintain.

More step height issues, settlement and damage.....

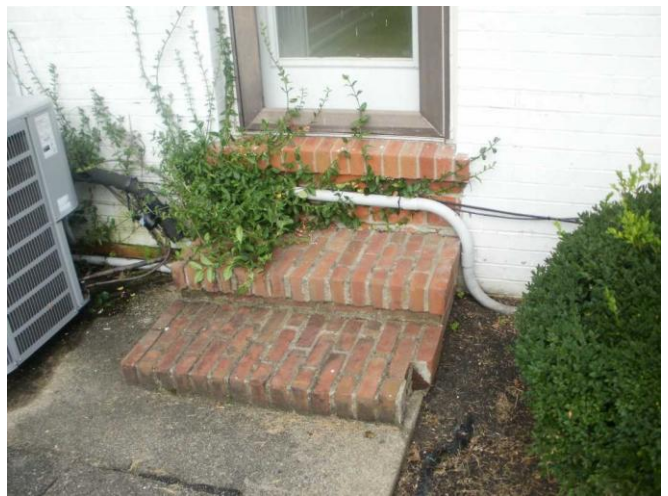
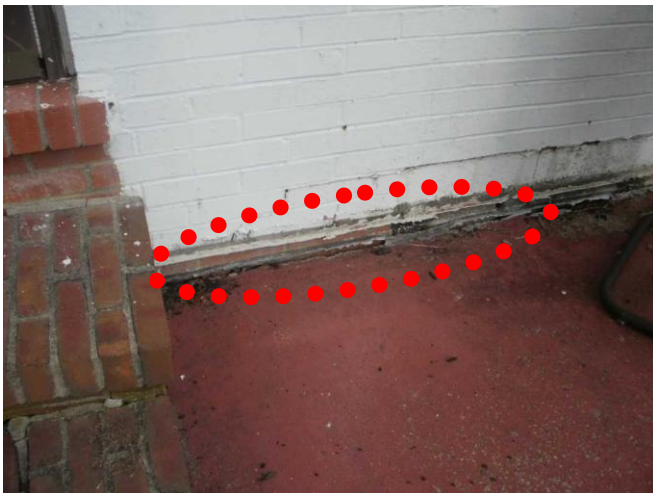
Sample rear patio settlement.

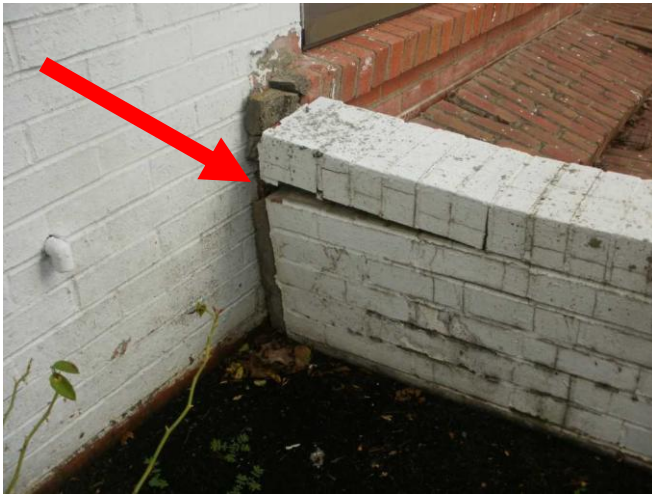
Sample damaged patio wall areas.

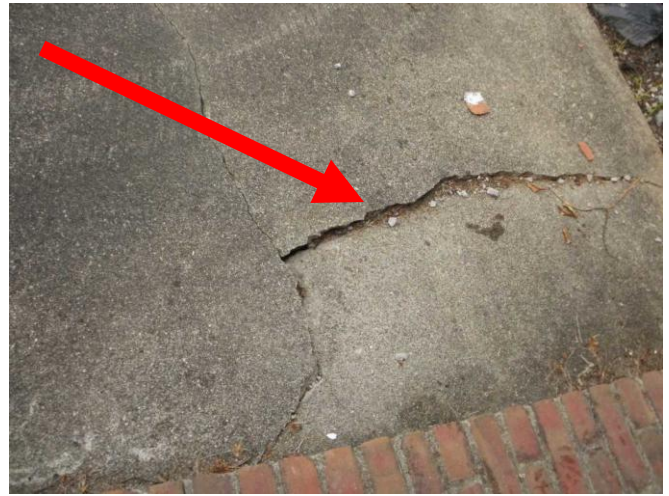
Outside patio at office settled and cracked.

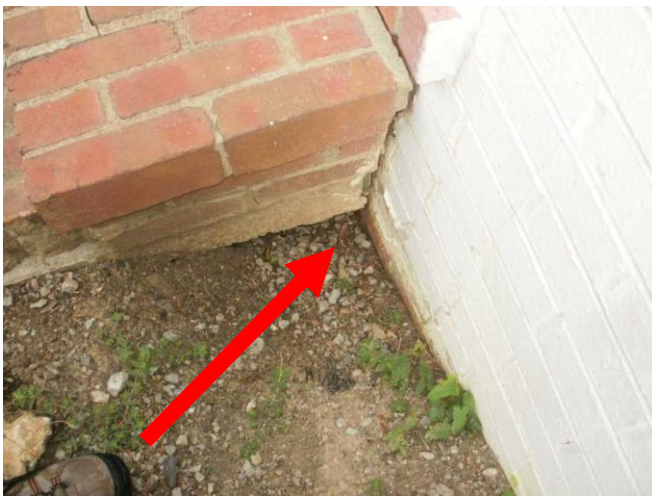
- Note: The side doors of the front right office appears to have an animal dug out under the steps. They are now pulling away from house. Recommend correction with #5 above.

Digging under side steps.

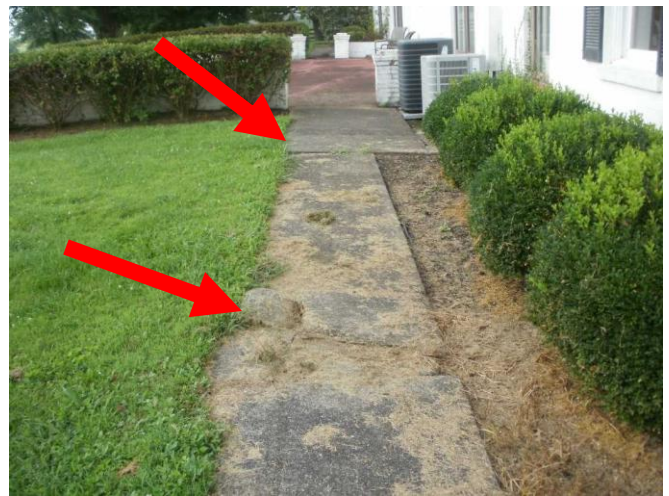
Sample cracked sidewalks and more sloping.

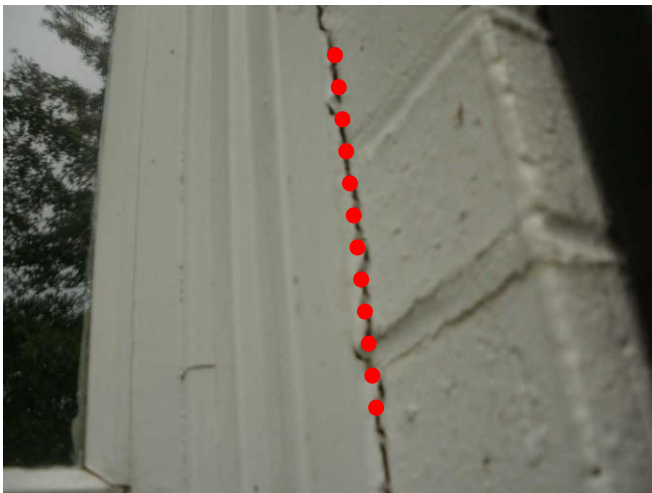
Sample sealant around windows to brick.

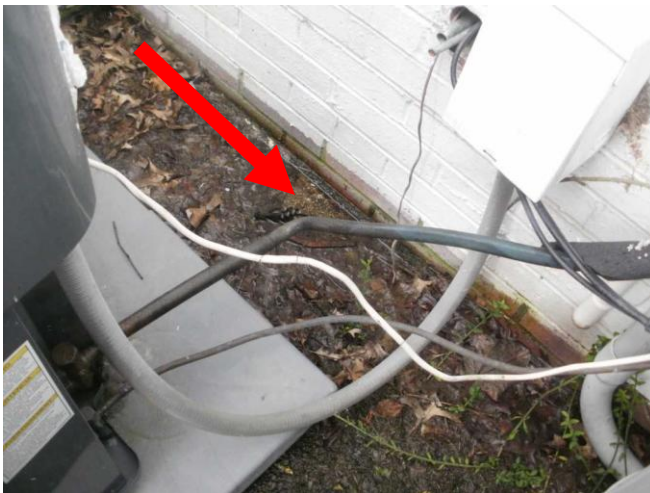
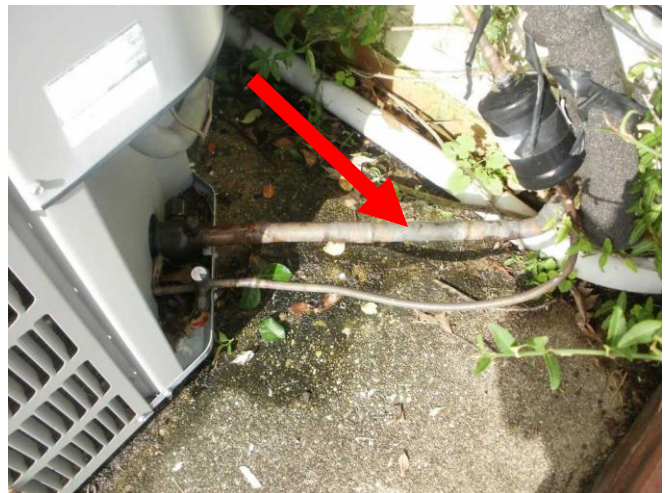
1. Line set insulation on both units are damaged/missing.
2. Unit 2 filter was dirty and not cooling very well. Some trunk work in attic is not insulated (areas today were sweating).  
Correct as needed. Service call recommended.

Sample maintain line set insulation both units.....

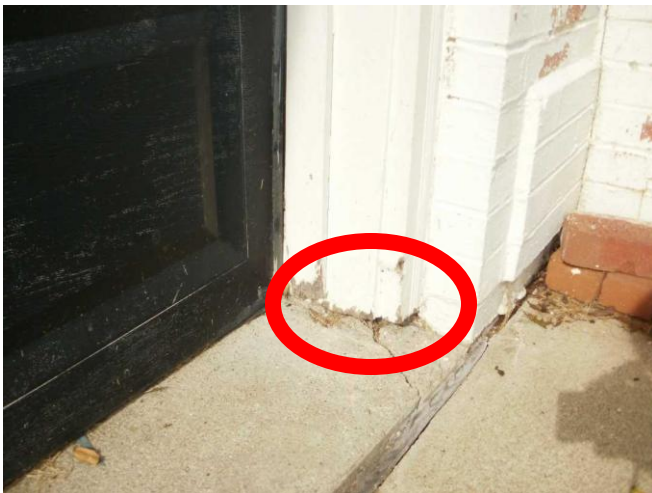
Door frame damaged wood.

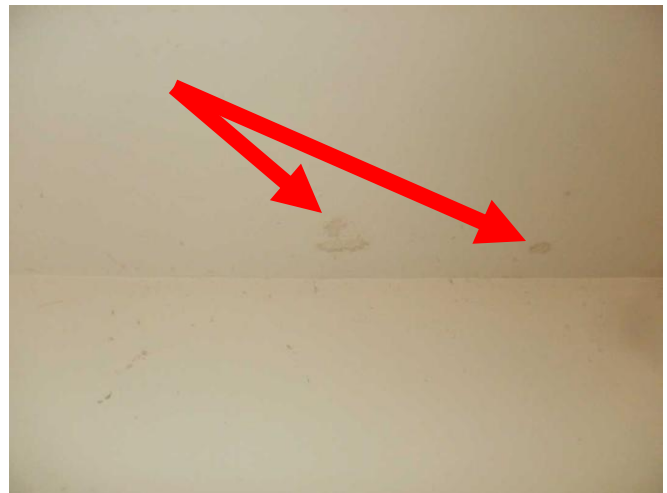
Ceiling staining.

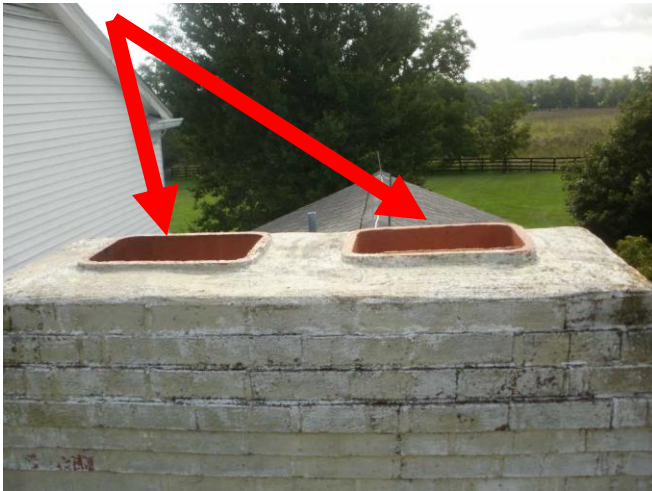
Sample no caps or screens.

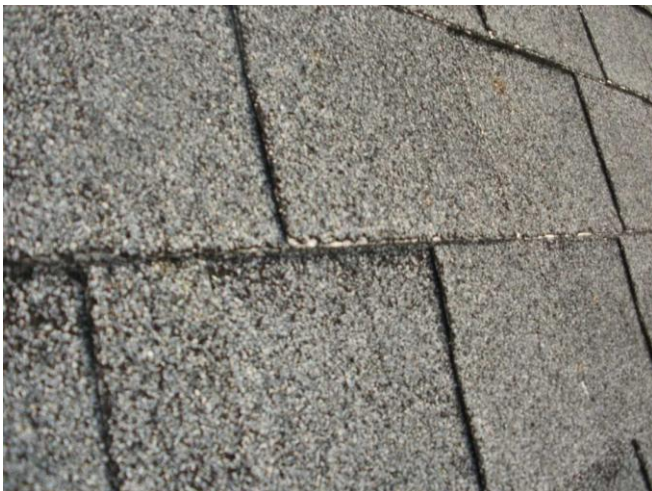
Up close of shingle wear.....Sample larger area above master bedroom.

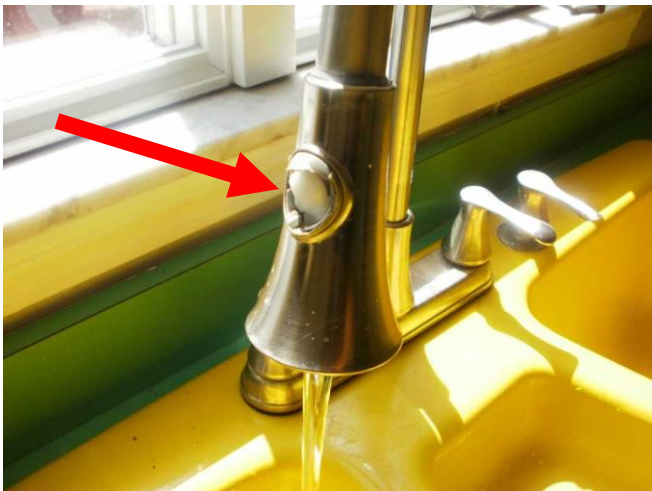
Sink sprayer button damaged.

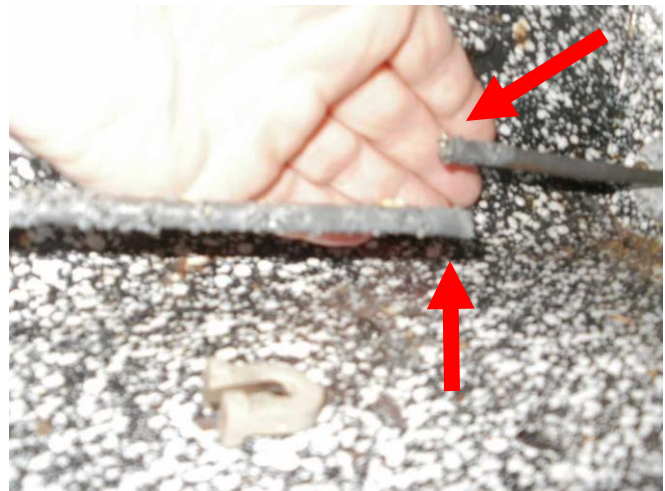
Upper oven element damaged.

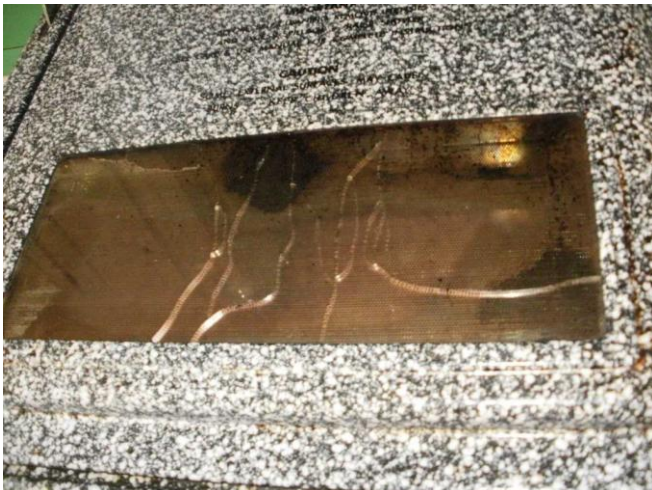
Upper over inside door glass damaged.

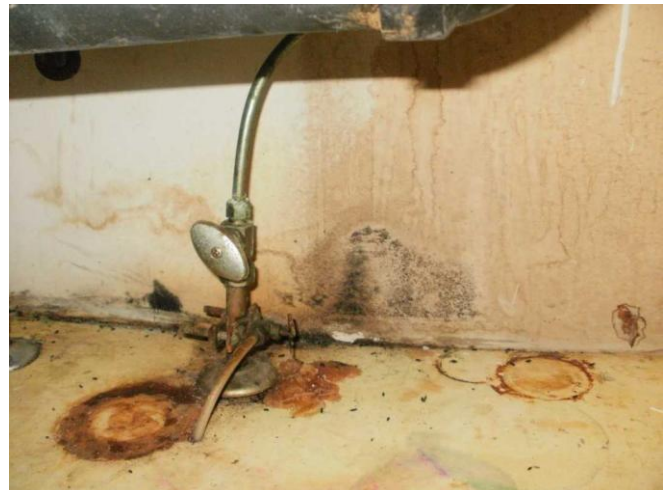
Sample bio growth under sink.

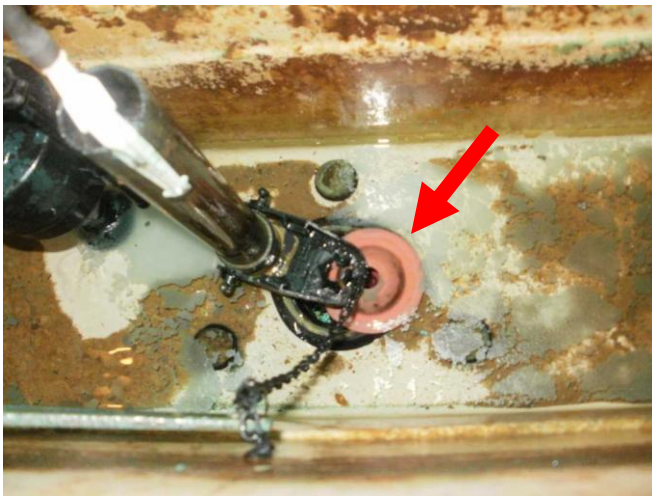
- Bath 2 toilet flapper was not the right size and was damaged, the refill kit needs replaced, soft wood noted between the toilet and tub, tub stopper was not functional and drain pipe under the sink was not installed properly. Door did not latch when closed. Correct as needed.

Bath 2 toilet flapper damaged.

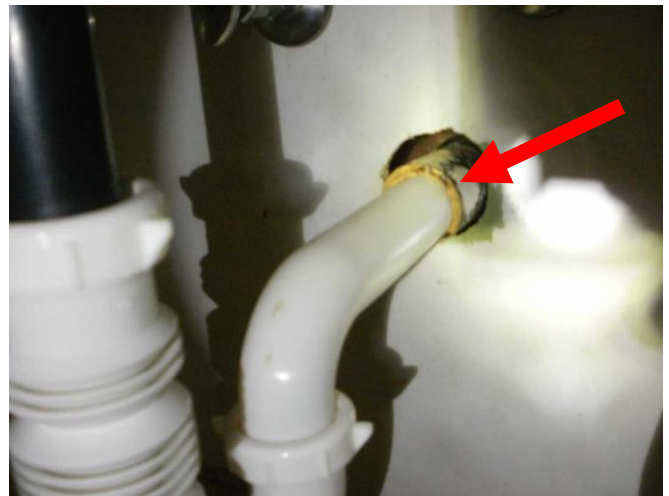
And sink drain concerns.

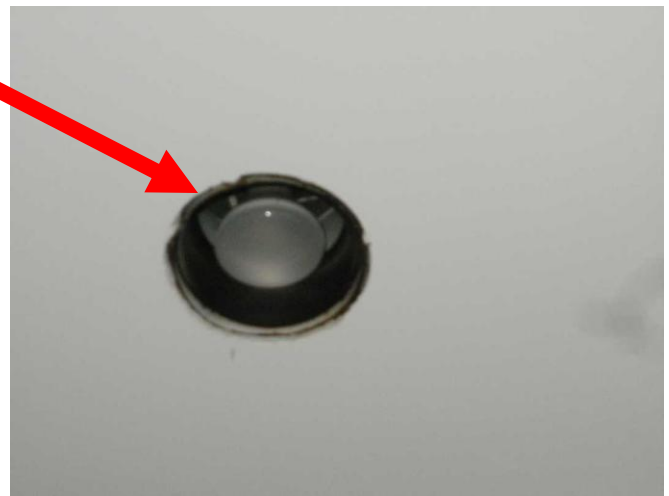
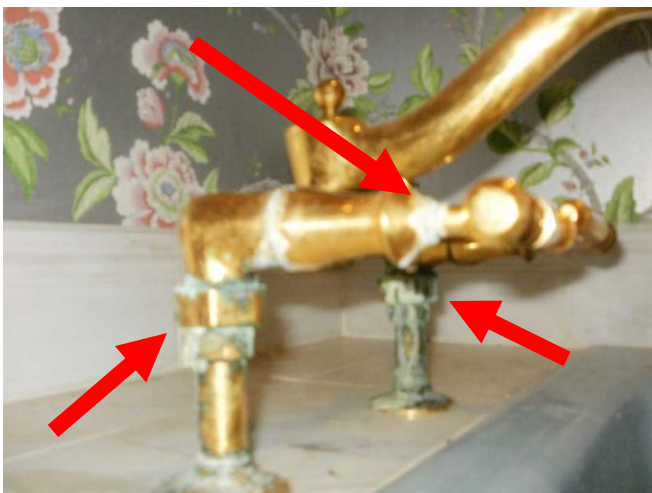
Leaking concerns at bath 1 tub controls.

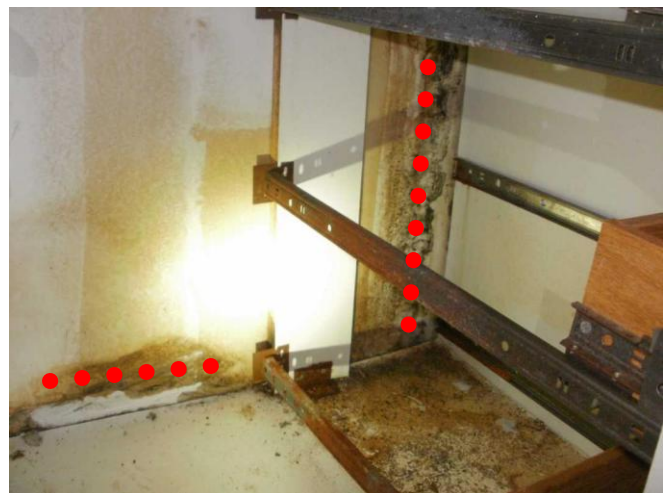
Bath 5 under sink, bio growth.....

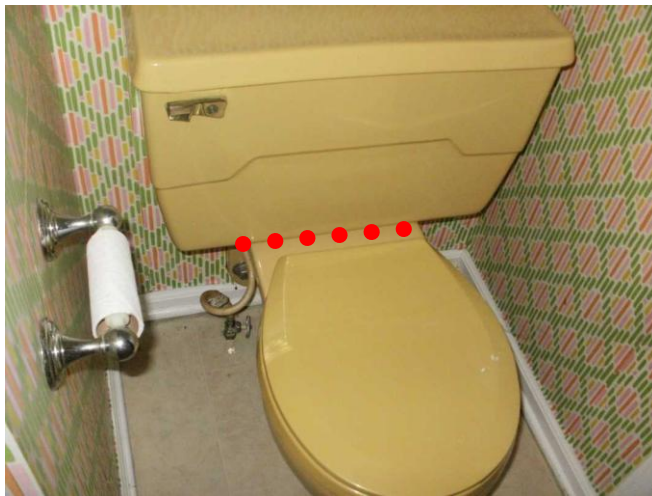
**Toilet tank to bowl leaking.**

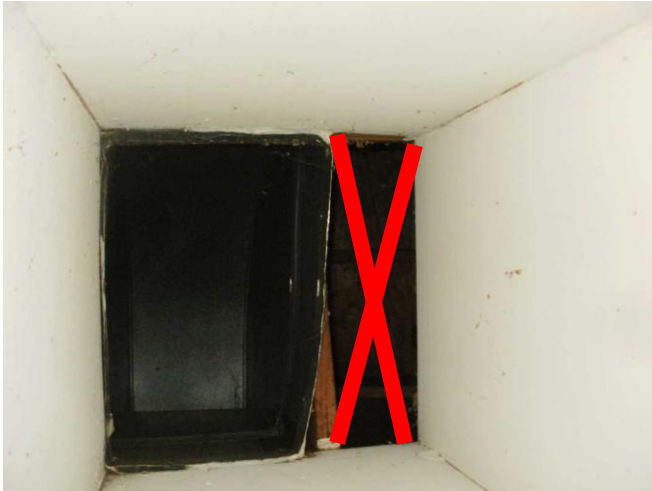
- 3. Part of the ceiling in hall closet (appears to be laundry chute) was missing.
- 4. Swinging door into dining room not working as intended and the double doors from hall into family room has a top ball assembly that is damaged. Correct as needed.

**Laundry chute closet missing ceiling areas.**

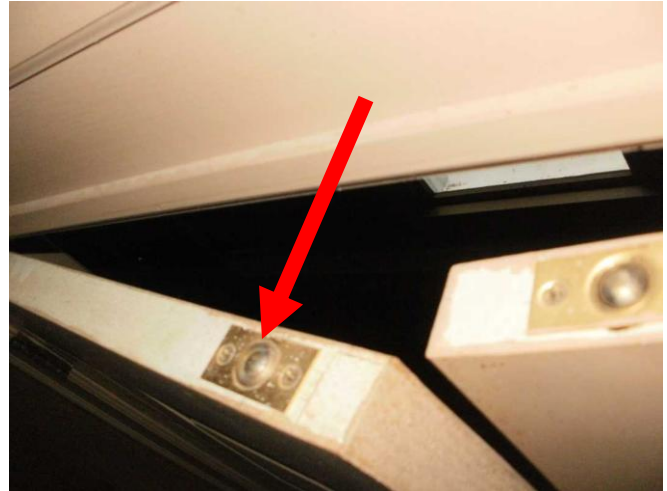
**Door ball assembly damaged. (replaceable part)**

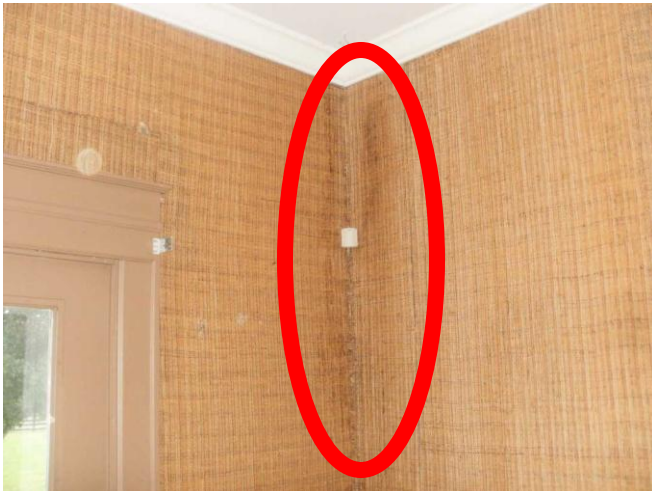
- \*5. Some discoloration is visible with loose areas at the family room corner adjacent to exterior master bedroom corner. Could be hidden damage. It appears wall paper is attached to paneling.

**Stained and damaged corner concern.**

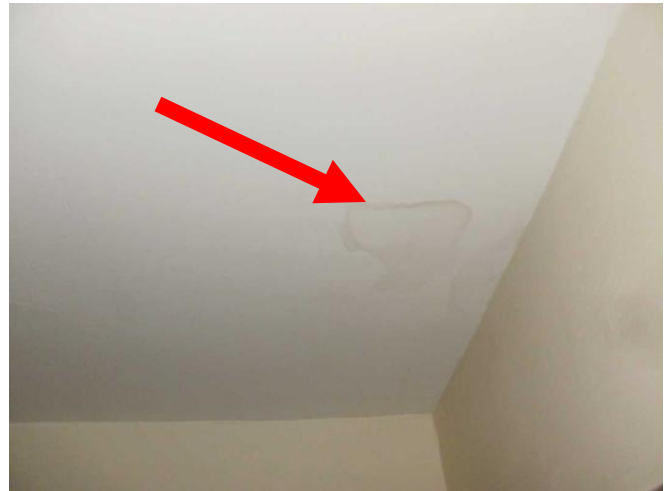
**Damp staining on ceiling by water heater closet.**

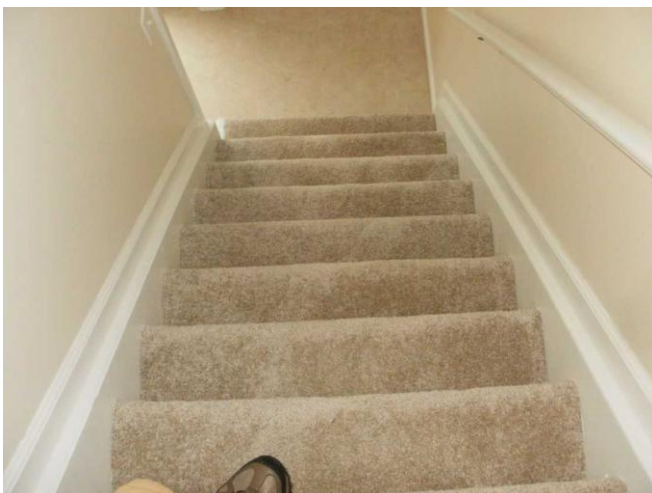
**Steep steps at rear hall and shallow treads.**

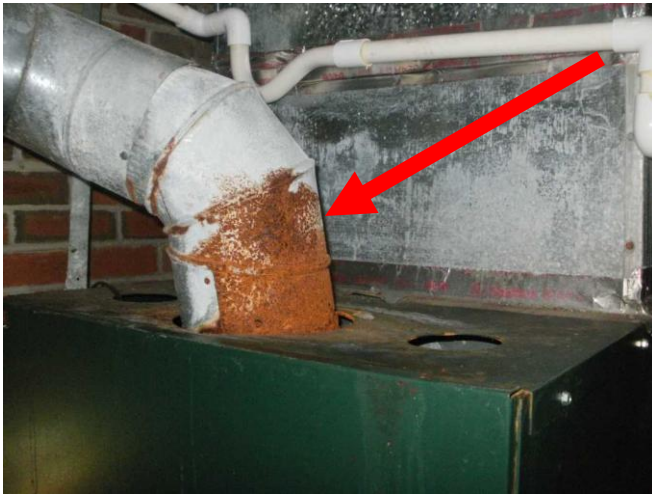
1. Unit 1 gas vent is rusting, it appeas the condensation drain can't drain properly and is leaking from evap coil area (causing ponding on floor-possible). The filter is a flimsy re-usable type. Correct as needed.
2. Some duct is rusting in the basment. Correct and maintain.

Rusting gas vent unit 1.

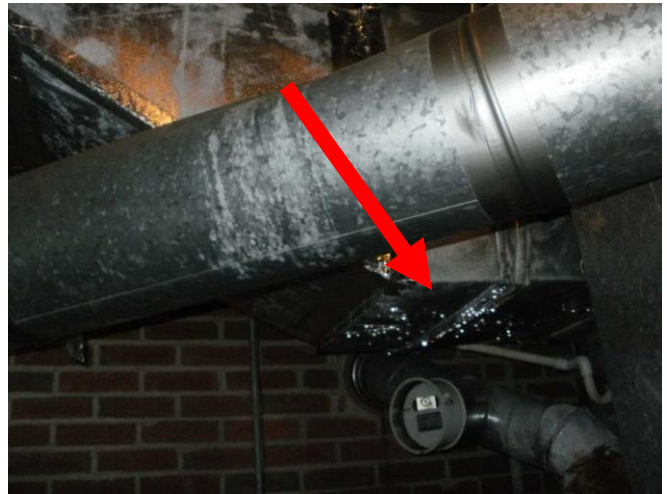
Water coming from evap coil area of unit 1.

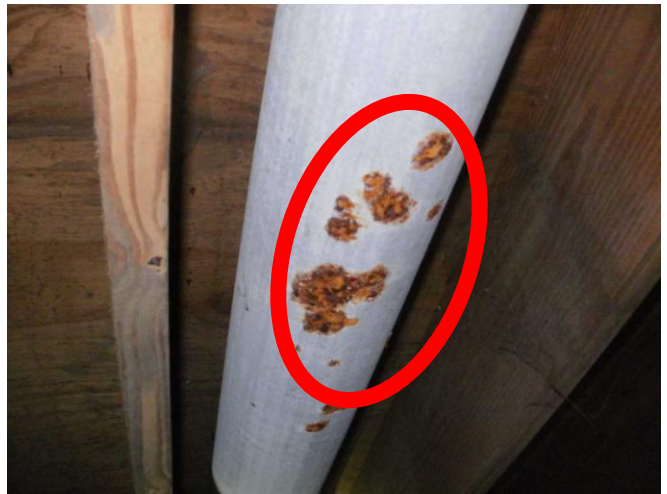
Rusting supply vents.

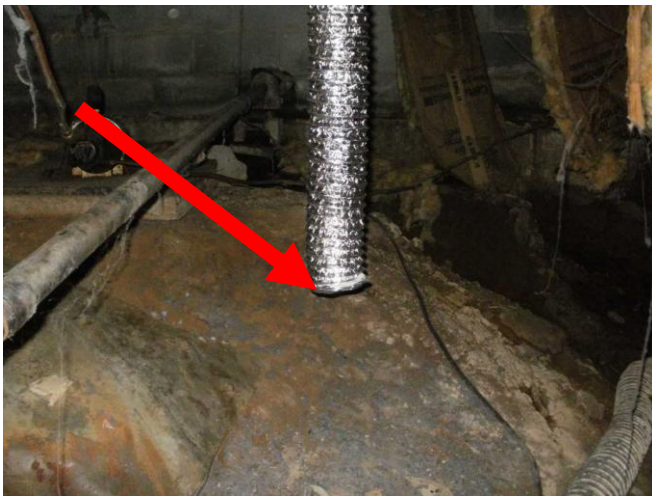
1. Maintain dryer vent for safety. Vents to crawlspace. Needs to outside.

Dry vents to crawlspace.

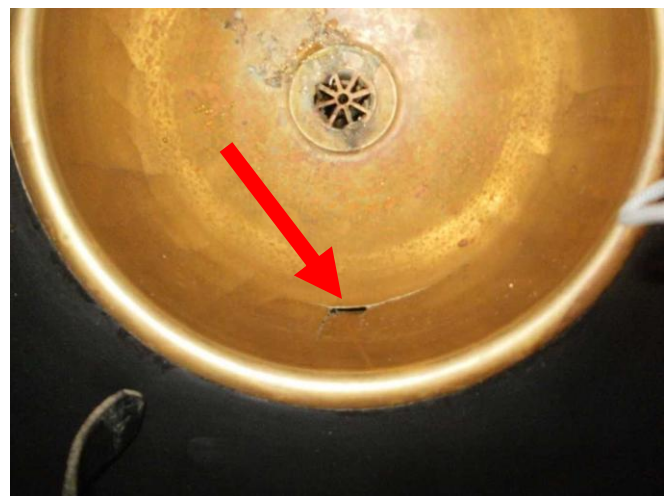
4. The sink at the wet bar is damaged. It also has no water pressure. Correct as needed. Note The outlet here is not GFCI protected (but not required for this age house.)

Wet bar sink damaged.

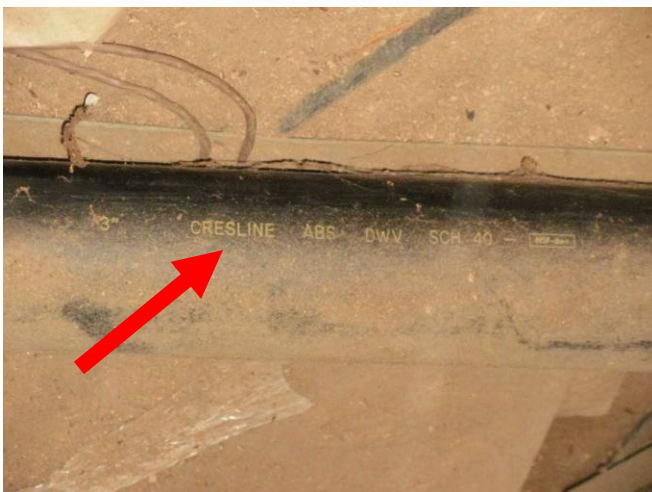
\*5. Black ABS visible in the attic. This brand is crestline and could have issues. (Can google "Black ABS pipe"). We recommend a plumber fully evaluate and make any needed repairs.

Current ABS drains.....Sample past manufacture issues.

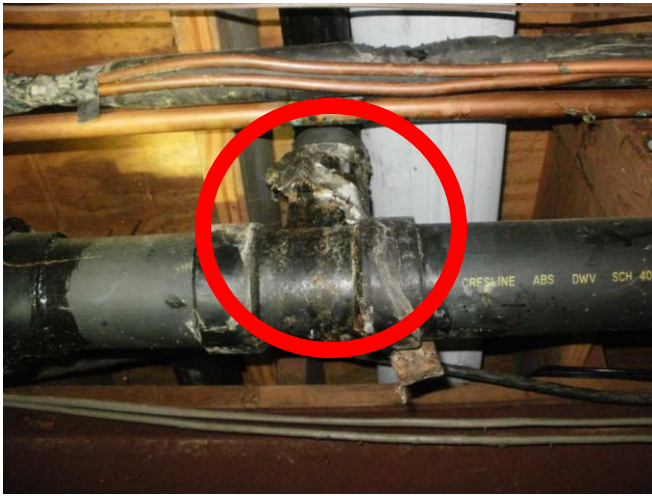
6. A section of drain line in the basement toward fireplace and center girder has past patch with DUCT tape. Correct as needed properly.

Duct tape repairs on drain line.

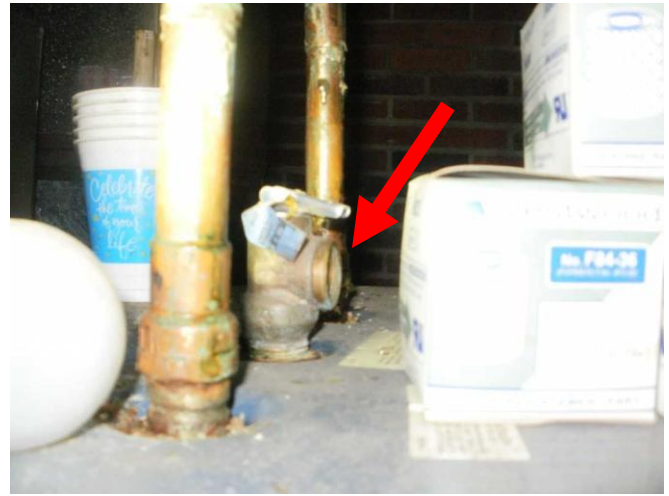
\*7. Unit 1 was older with no T/P drain pipe. Correct for safety.

Unit 2 water heater. No t/p drain pipe.

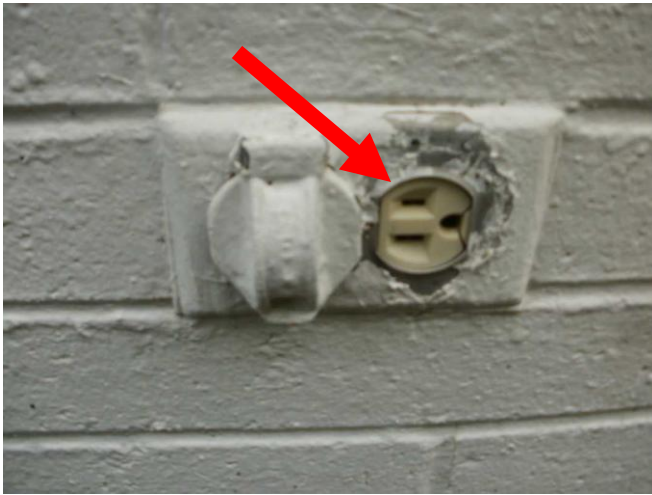
**Damaged weather cover.**

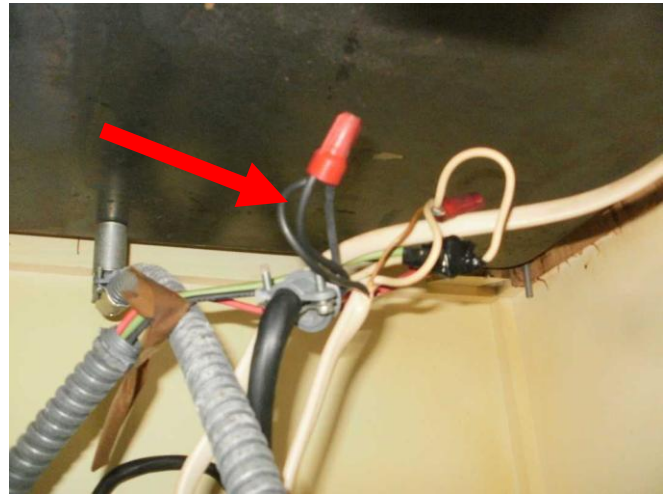
**Wire splice to cook top.**

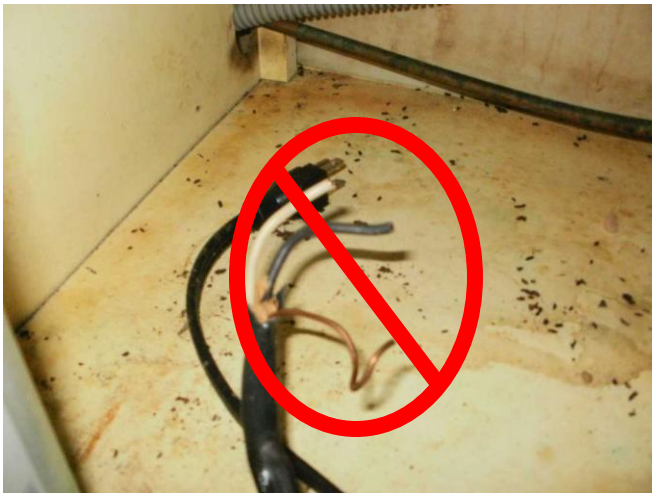
**Disposer wire and improper wire termination.**

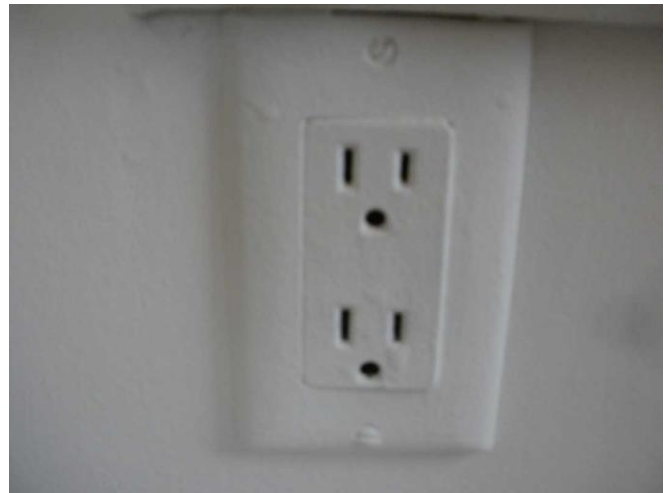
**Sample outlets painted over or not tested. (Tight fitting)**

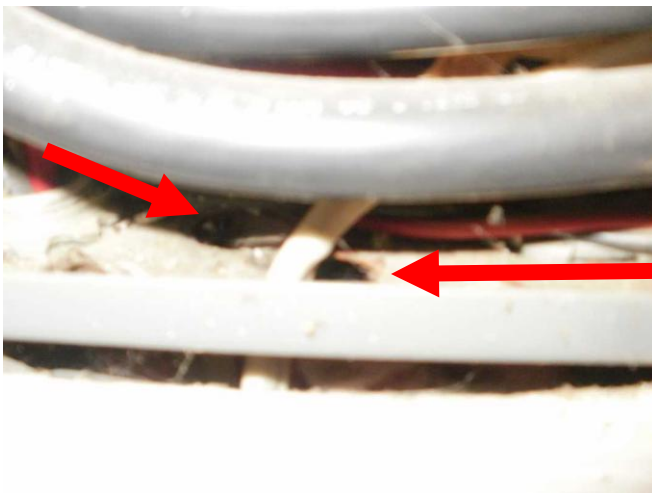
**Missing romex fitting and filler cap needed.**

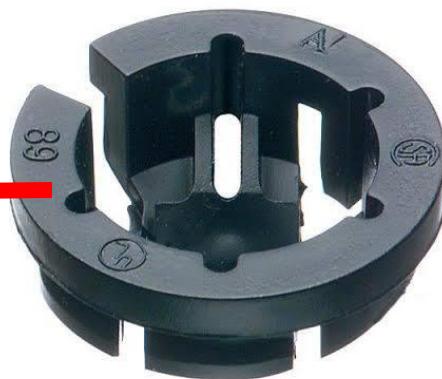
**Sample plastic romex fitting.**

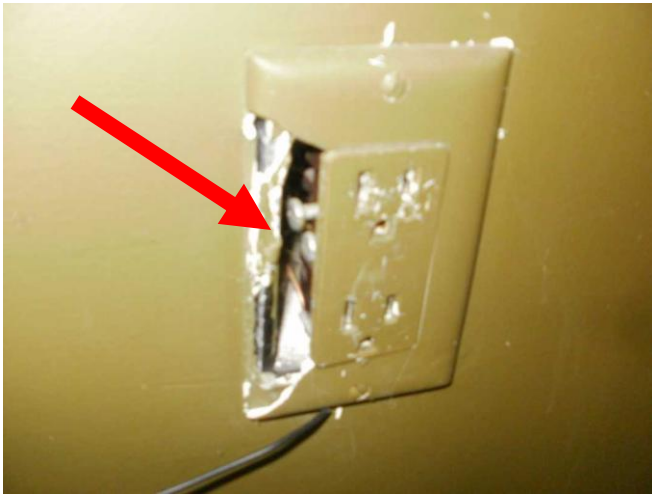
**Damaged cover plate in office.**

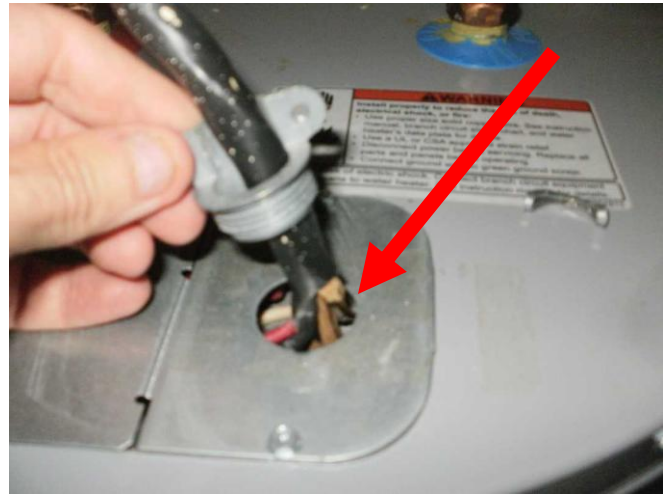
12. Bath 4 outlet between the doors at sink was not GFCI protected. (Not required for this age.)
- \*13. Water heater wire romex fitting is not properly installed at wire entry. Correct needed.

**Unit 1 water heater romex concern.**

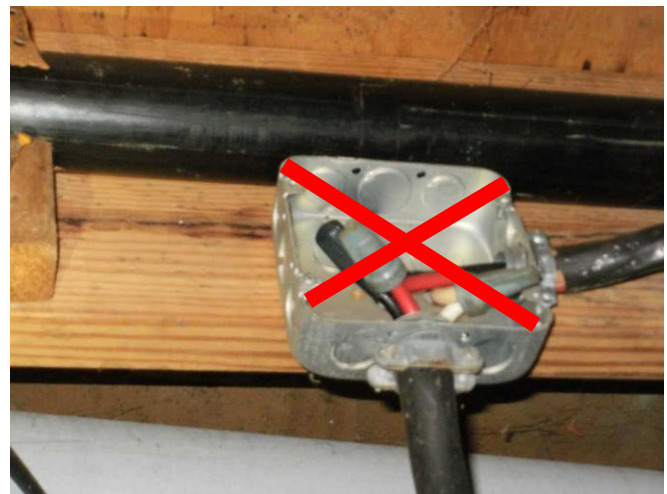
**Missing cover plate in basement.**

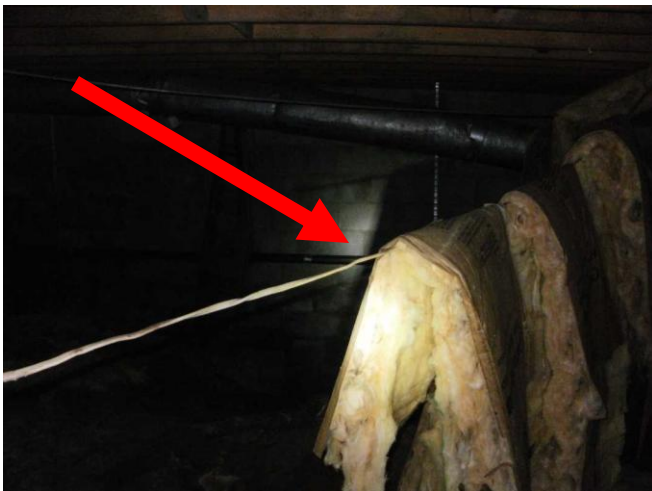
\*16. Some electric wires in crawlspace are not supported properly to floor joists and have falling insulation hanging from them. Correct for safety.

**Some wires are not secured and are holding insulation.**

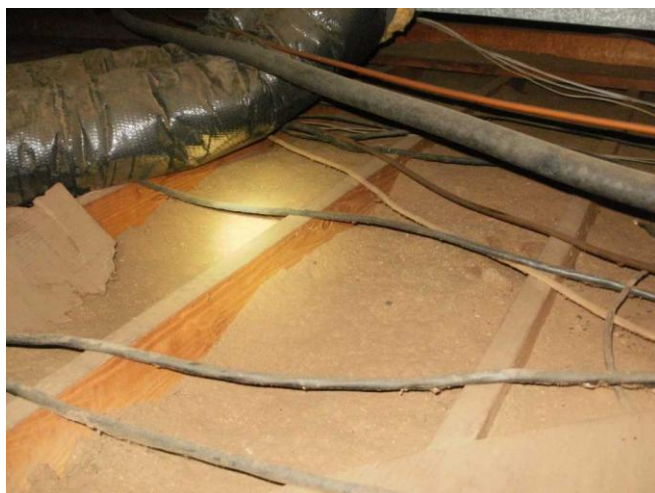
- \*1. Soffit areas in the attic appeared to be closed off. Limited air flow across the attic. Insulation was limited. This can increase temps in the house and decrease shingle life. Correction recommended.
- 2. Older furnace and furnace part scattered around attic. Recommend removal.
- 3. Some of the flooring was thin. Use caution.

**Limited insulation around attic.**
