## ***Home Inspection Report***

# ***Mundy's Home Inspection Inc.***

<b>Client:</b>	Mr. Sample	<b>Inspection #</b>	12345
<b>Subject Property:</b>	345 Pick a Place Rd Lexington, KY 40511	<b>Date:</b>	8-18-2021
<b>Telephone No:</b>	859-123-4567	<b>Time:</b>	9am
<b>Building Type:</b>	Residential	<b>Age:</b>	1970
<b>Occupancy Status:</b>	Vacant with furnishings	<b>Sq. Ft.:</b>	5120
<b>Persons Present:</b>	Buyer, Buyer Agent	<b>Fee:</b>	\$720
<b>Inspection Service:</b>	Whole house	<b>Temp:</b>	Mid 70s
<b>Weather Conditions:</b>	Partly cloudy, warm	<b>Page</b>	27

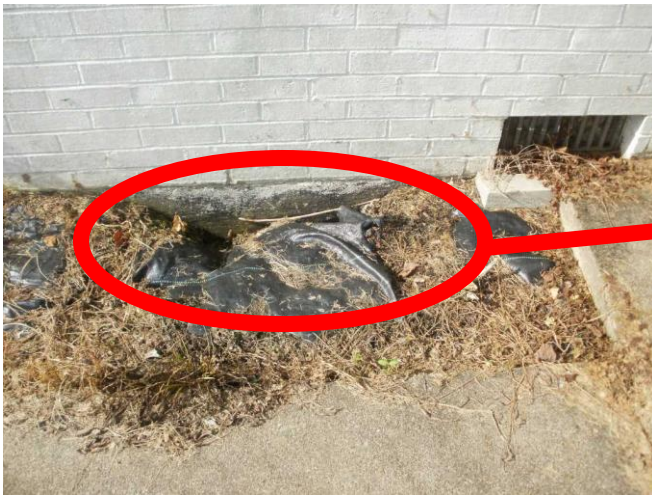
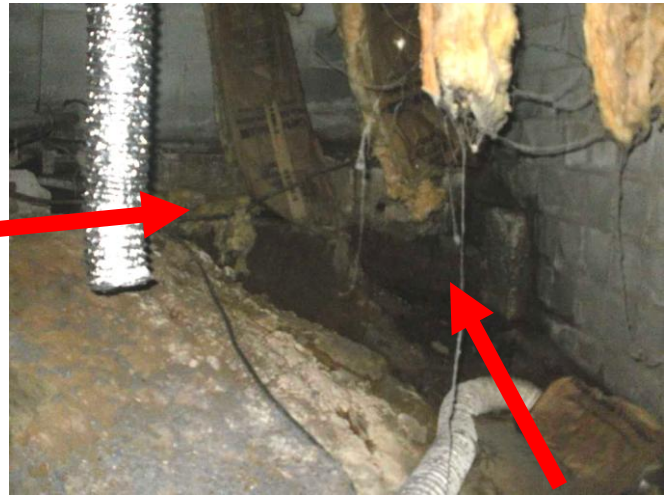
- \*1. 2x6 roof joists appear to be overspanned and have some sag. No knee walls are installed. This can help reduce sag or keep from further movement. Recommend evaluation and repairs by a Qualified contractor.
- \*2. The sump pump was full upon arrival but float would not kick on. It appears the float level is above the drain tile and is allowing water to not drain properly. It also appears the condensation drain may go to this drain and since it wont pump out... the condensation line fills and leaks out at the evaporator coils of unit-hince the pond on the floor. (Water is dripping from the evap coils of unit 1.)
- \*3. A lot of soil has eroded from footer area at the left rear corner of house. This should be restablized. Correct as needed. It appears the soil depression on that side of the house has washed thru the crawlspace and is a major concern.

Depression by garage.....Soil erosion at same area of crawlspace. Footer seen.

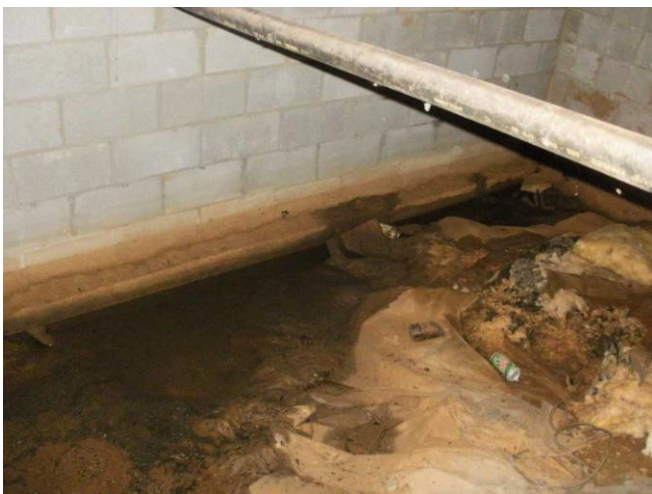
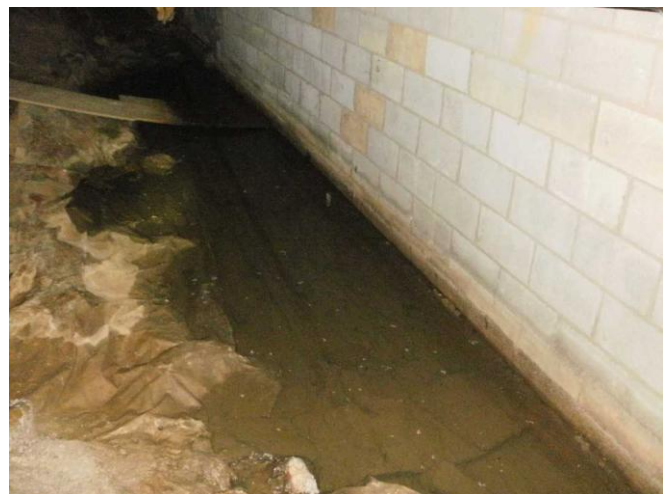
1. Both areas of the crawlspace have water standing at the basement foundation walls. Soil erosion is visible in areas. Most insulation has fallen down and got damaged. Correct and maintain.
2. Some Bio growth possibly under right side master window, visible in crawlspace. Correct as needed. Wood appears solid. Dry today.

Water standing in left side crawlspace at basement wall... and right side crawl against basement wall.
