## ***Home Inspection Report***

# ***Mundy's Home Inspection Inc.***

<b>Client:</b>	Mr. Sample	<b>Inspection #</b>	12345
<b>Subject Property:</b>	345 Pick a Place Rd Lexington, KY 40511	<b>Date:</b>	8-18-2021
<b>Telephone No:</b>	859-123-4567	<b>Time:</b>	9am
<b>Building Type:</b>	Residential	<b>Age:</b>	1970
<b>Occupancy Status:</b>	Vacant with furnishings	<b>Sq. Ft.:</b>	5120
<b>Persons Present:</b>	Buyer, Buyer Agent	<b>Fee:</b>	\$720
<b>Inspection Service:</b>	Whole house	<b>Temp:</b>	Mid 70s
<b>Weather Conditions:</b>	Partly cloudy, warm	<b>Page</b>	27

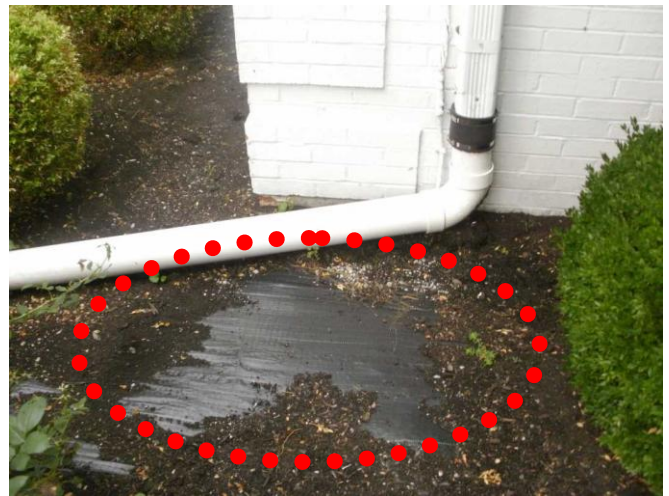
- \*4. Ponding is visible around house. It appears that past overflowing gutters have caused soil erosion in areas, mostly around the front. A depression was also visible at the left side of house toward the rear, just past the driveway, against the house and around basement window wells. These can allow water into the basement or crawlspace.

Signs of ponding around house.

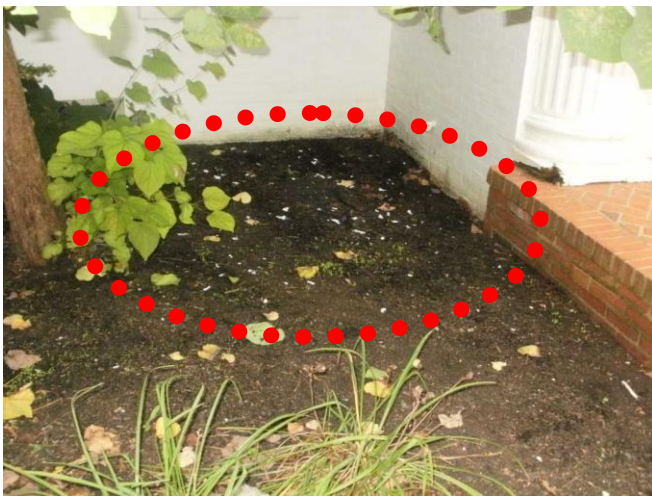
More ponding.....And areas slope toward house.

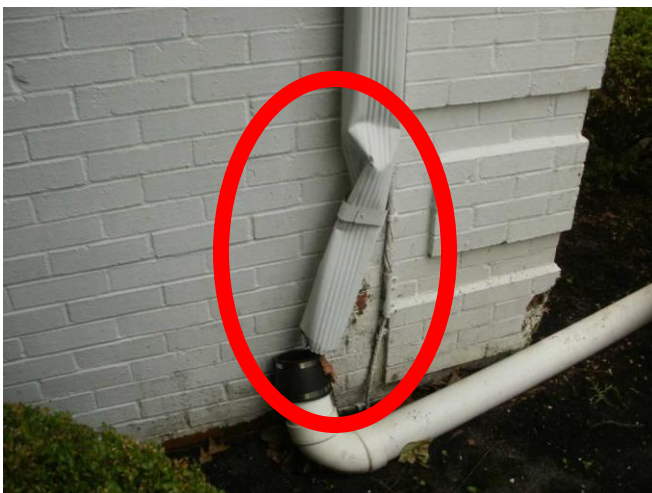
Drain pipe disconnected.

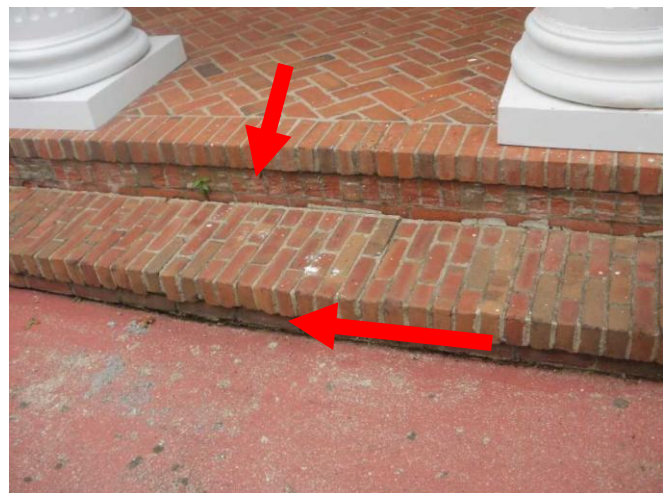
- \*5. The brick steps around the house are have differing step heights. Various areas (ie:rear steps off family room have settled and broken front porch steps have some loose or missing.) Various sidewalks have cracked, the side patio at office and rear patio has settled and slopes toward the house (Funneling water toward the rear of house.) Can be a trip hazard and should be replace and solid surface areas like patios and sidewalks against the house should slope away from the foundation. Some of the brick patio walls have broken in areas. Correct and maintain.

Step height concerns. Sample.

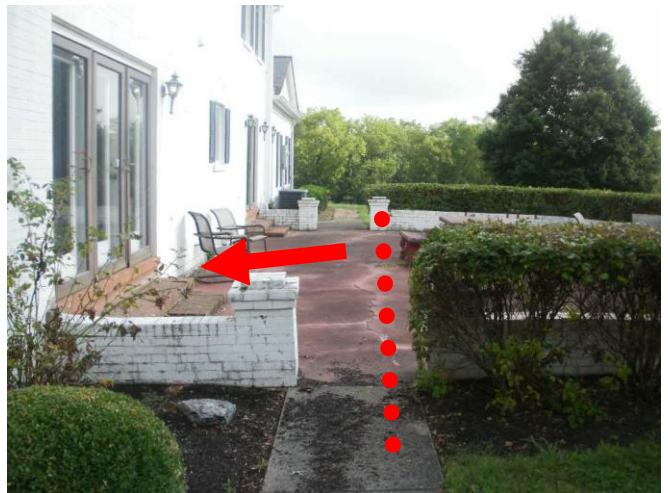
Sloping toward house.

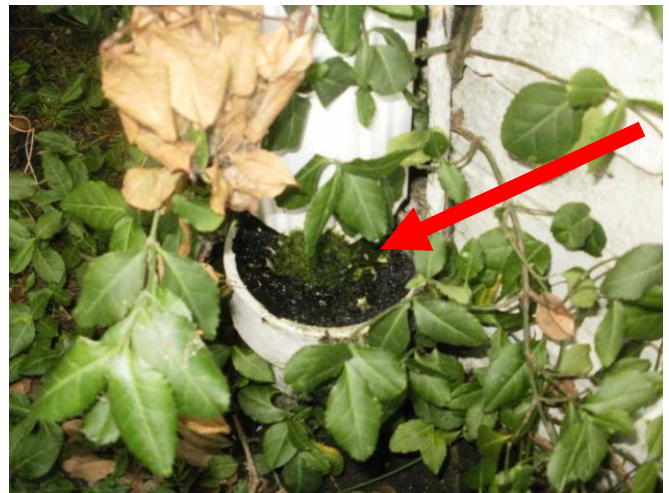
6. Maintain sealant at brick to windows.
  7. The right rear downspout drain pipe is not functional. Correct and maintain.
  8. Maintain Ivy around house. Can cause moisture concerns or damage.

Right rear downspout to drain (Clogged concerns)

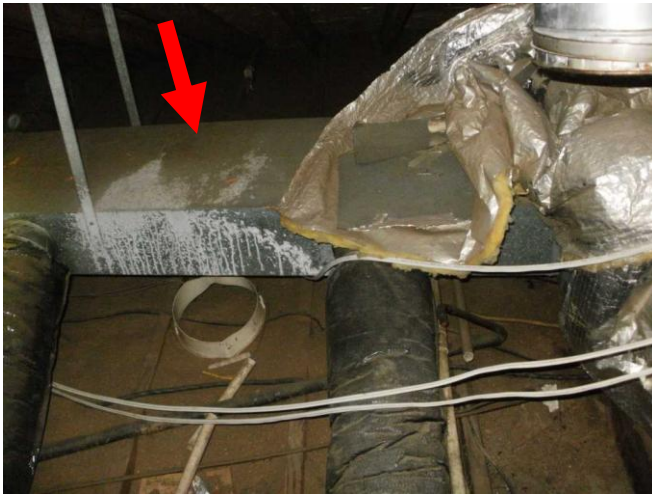
1. Line set insulation on both units are damaged/missing.
2. Unit 2 filter was dirty and not cooling very well. Some trunk work in attic is not insulated (areas today were sweating).  
Correct as needed. Service call recommended.

Trunk in attic not insulated and sweating. Sample.

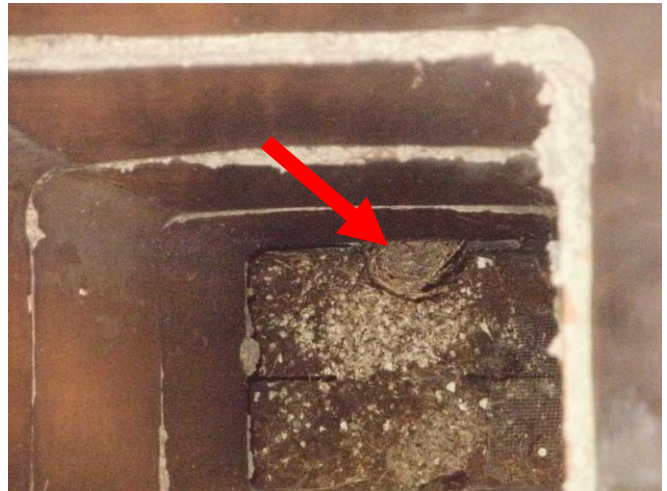
Sample visible nesting in chimney.

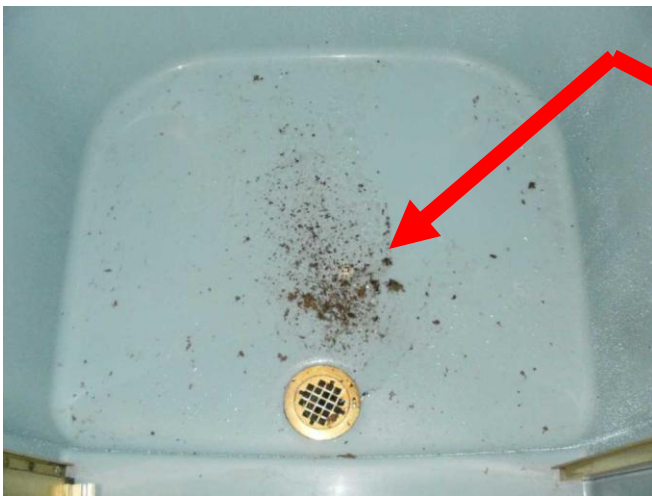
Stuff in bath 1 shower and tub from recessed lights.....No trim kits.

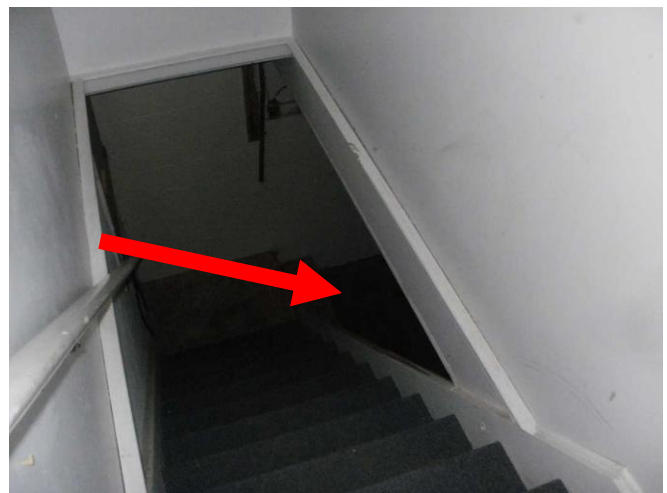
**Open railing to basement.**

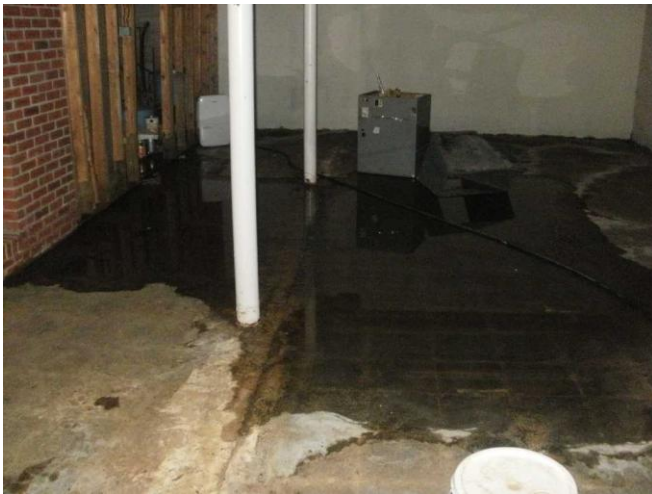
Pond on basement floor from furnace area.

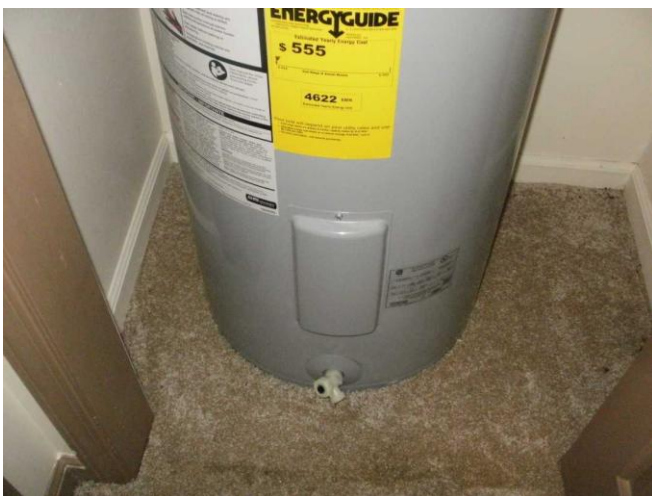
No overflow pan with drain to outside.

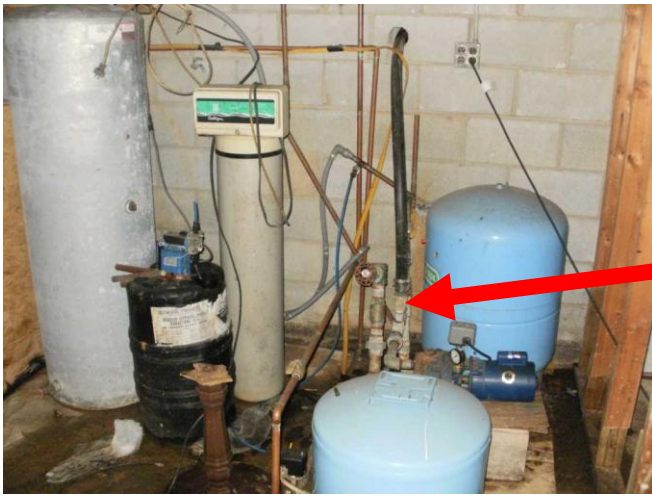
Pressure tank, pump and softener.

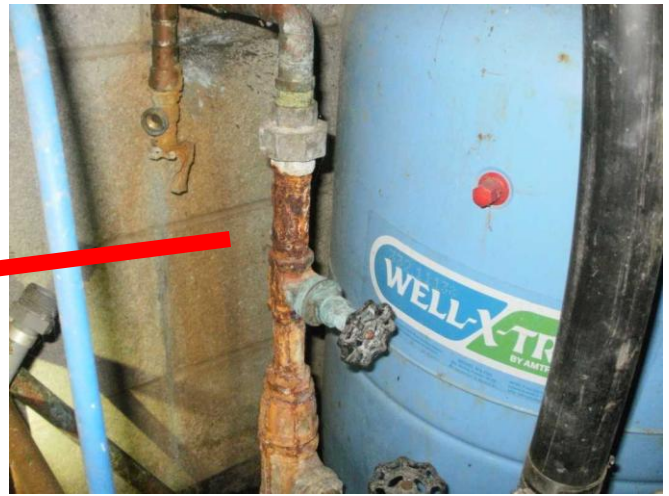
Concerns.

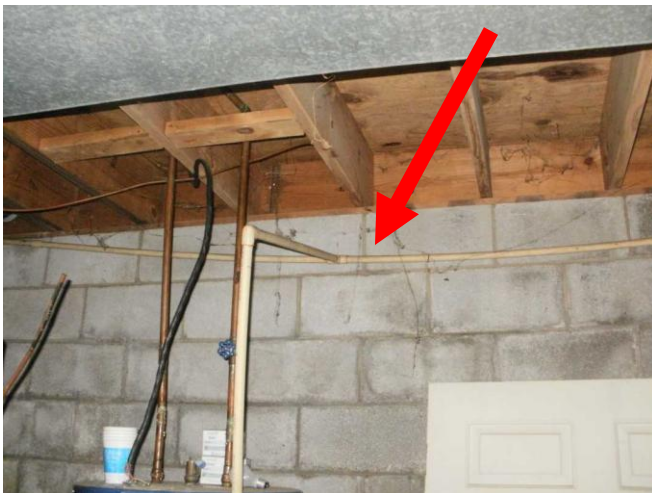
CPVC pipe needs support.

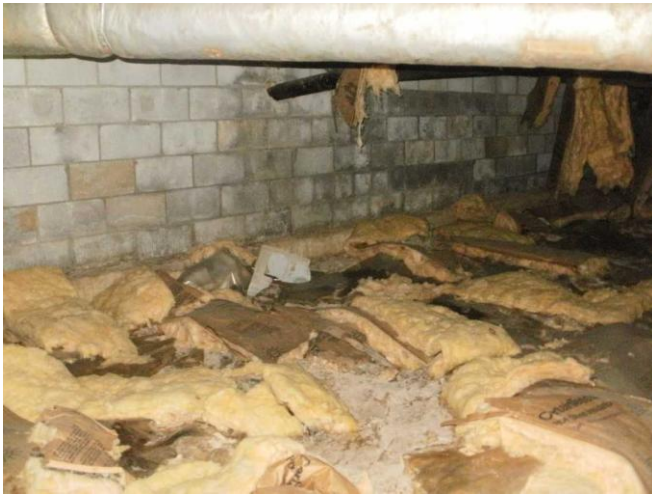
Sample insulation has fallen down. Signs of damp walls.

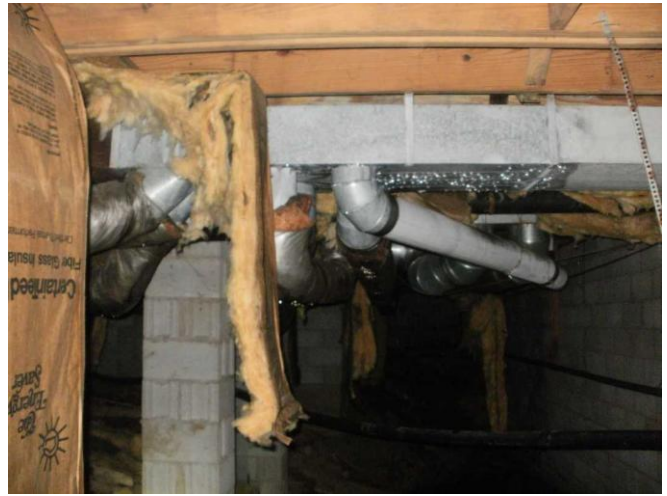
Some still falling.
